Technical Paper 1198

Wear of Single-Crystal Silicon Carbide in Contact With Various Metals in Vacuum

Kazuhisa Miyoshi and Donald H. Buckley

NASA Technical Paper 1198

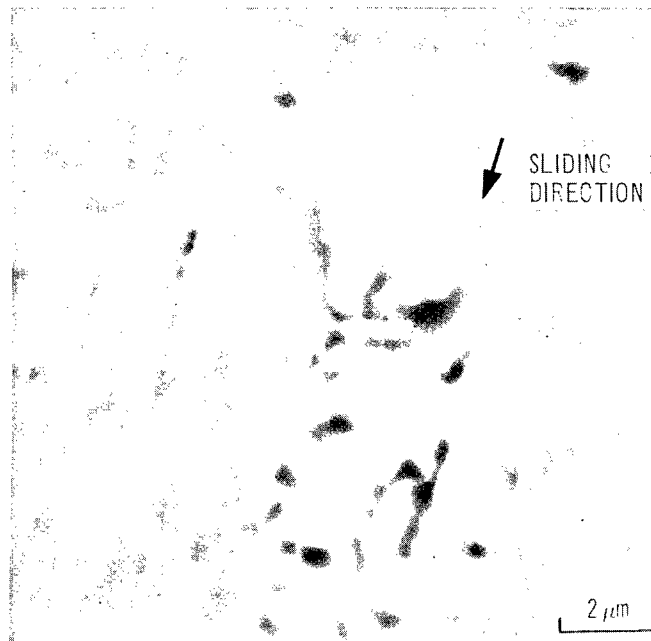
(a) Scanning electron micrograph.

(b) Silicon K_{α} X-ray map of cobalt rider; 1.0×10^4 counts.

Figure 7. - Indentations on cobalt rider produced by rolling of silicon carbide wear debris during sliding contact. Ten passes on SiC (0001) surface; sliding direction, $\langle 10\bar{1}0 \rangle$; sliding velocity, 3 mm/min; load, 30 g (0.29 N); temperature, 25° C; vacuum pressure, 10^{-8} Pa.

The wear scars on metals after sliding on silicon carbide surfaces may contain the silicon carbide wear debris. Figures 5 to 7 indicate that the wear debris of silicon carbide, produced in sliding on rhodium, copper, and cobalt, transferred to or was embedded in the metal riders. The wear debris generally slides or rolls on the metal surfaces and produces the indentations and deep grooves shown in figures 5 to 7. Figure 6 shows straight grooves, along the sliding direction on the metal, formed by the sliding of silicon carbide wear debris. Figure 7 also shows straight rows of indentations, along the sliding direction, formed by the rolling of silicon carbide wear debris.

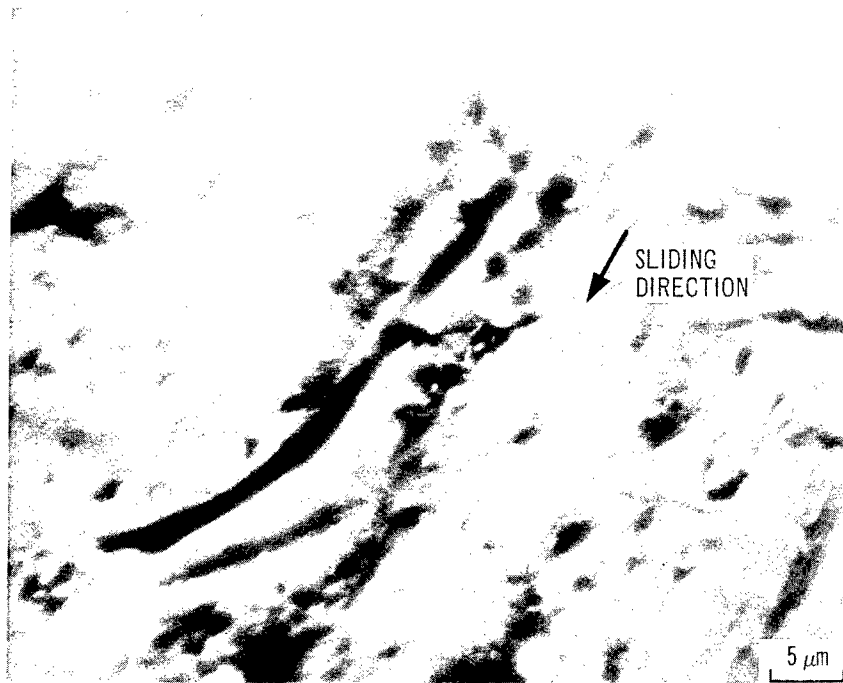
(a) Aluminum.

(b) Titanium.

Figure 9. - Wear scars on metal riders produced during sliding contact with silicon carbide. Ten passes on SiC (0001) surface; sliding direction, $\langle 10\bar{1}0 \rangle$; sliding velocity, 3 mm/min; load, 30 g (0.29 N); temperature, 25° C; vacuum pressure, 10^{-8} Pa. (Scanning electron micrographs.)

(c) Copper.

(d) Nickel.

(e) Cobalt.

(f) Iron.

The wear scars on the metal riders after sliding against silicon carbide revealed a large number of plastically deformed grooves and indentations (which seem to depend on the nature of transfer of silicon carbide and the metal) formed primarily by the sliding and rolling of silicon carbide wear debris. (See fig. 9.) The less the chemical activity and the greater the resistance to shear of the metal, with the exception of rhodium and tungsten, the less the transfer to silicon carbide (ref. 1). (See tables I and II.) The wear scars are generally rougher with aluminum and titanium, which have much stronger chemical affinity and less resistance to shear than copper, nickel, cobalt, or iron. The wear scar of iron is much smoother, with fewer deep grooves and indentations (fig. 9(f)). The titanium wear scar has the roughest surface (fig. 10). This reflects the large amount of silicon carbide transfer to titanium. Figure 10 reveals that most of the large contact indentations contain silicon carbide wear debris.
